Evaluation of 4H-SiC epitaxial layers by synchrotron x-ray topography

Isaho Kamata Central Research Institute of Electric Power Industry (CRIEPI)

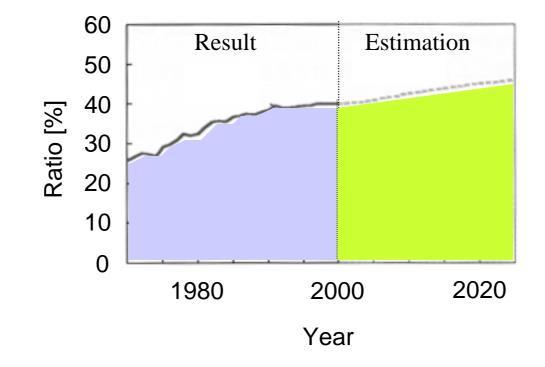
Ratio of electric power in total energy consumed in Japan in each year [1].

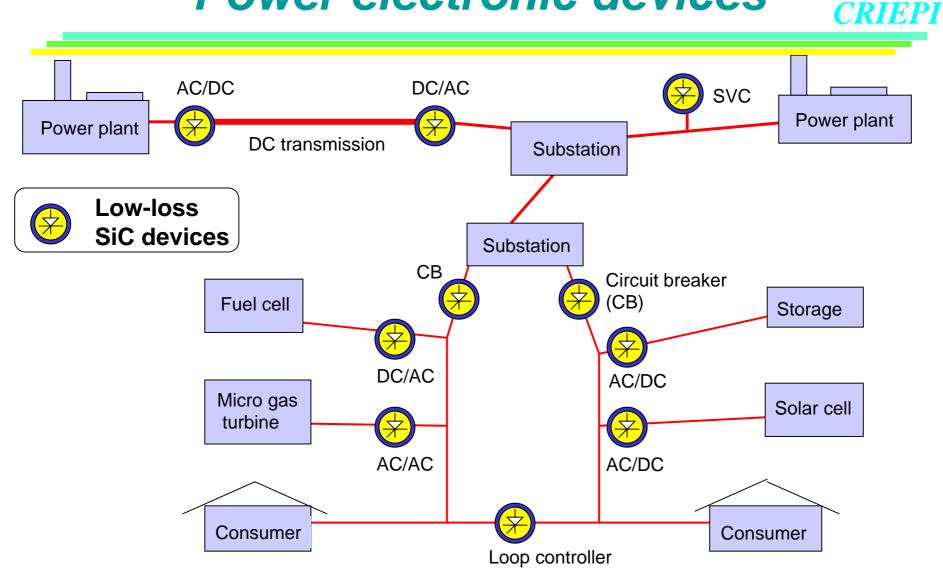
Electric power transmission and distribution systems in near future.

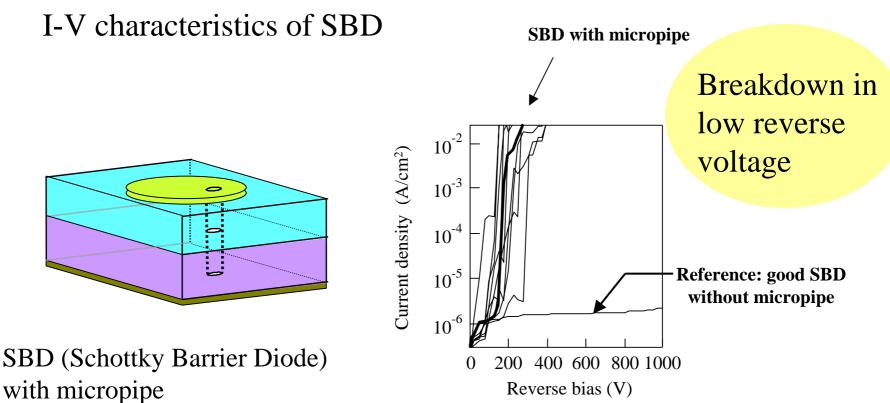
Influence of micropipe -for electrical property-

SBD (Schottky Barrier Diode)

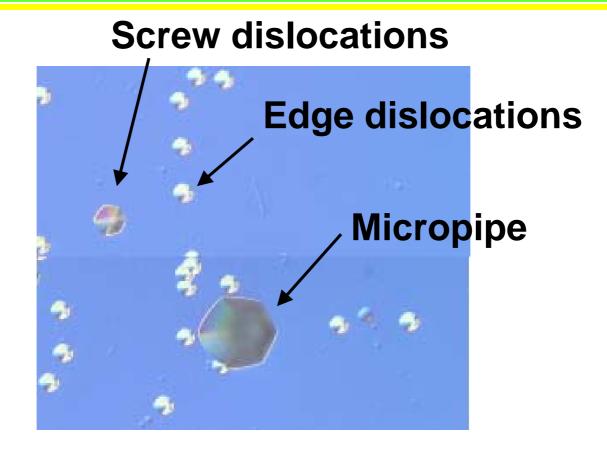
Evaluation of defect -KOH etching-

Dislocations are easily investigated by KOH etching as etch pits. However, the KOH etching is destructive evaluation.

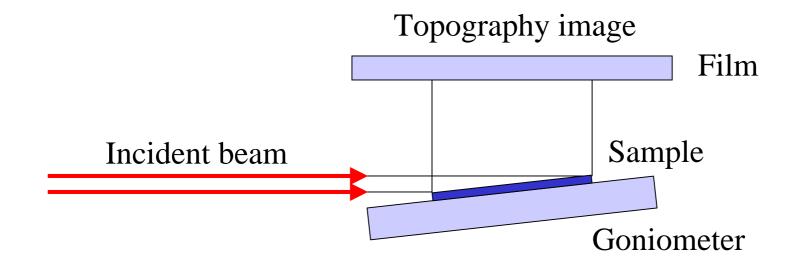
X-ray topography measurements

Energy [keV]	Wavelength [Å]	Diffraction	
~8 [keV]	~1.54 [keV]	$(1\overline{108}) \\ (1\overline{128})$

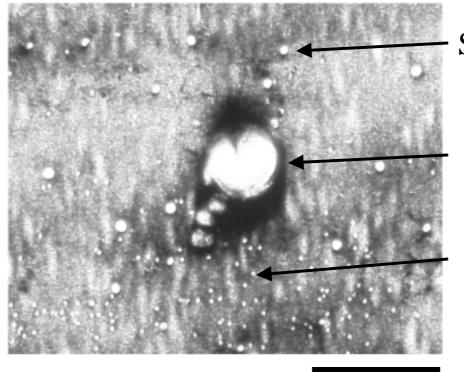
Evaluation of defect -X-ray topography-

Screw dislocation

Micropipe

Dislocations are observed by X-ray topography.

Dislocations (screw dislocations, edge dislocation and micropipes) are observed by the Synchrotron X-ray topography as a non-destructive evaluation.
